(c) NATIONAL PHOTOGRAPHIC INTERPRETATION CENTER	
REF	FERENCES: ATTACHMENT TO L-1613 23 AUGUST 1966 PAGE 1	
	PETROLEUM PRODUCTS STORAGE UNDERGROUND DUONG NHAM, NORTH VIETNAM 2101N 10630E	
	(SEE NPIC BRIEFING BOARD L-1225 FOR COMPARISON)	
1	SIGNIFICANCE:	
	THIS BRIEFING BOARD DEPICTS BOMB DAMAGE RESULTING FROM AN AIR	
	STRIKE ON DUONG NHAM PETROLEUM PRODUCTS STORAGE.

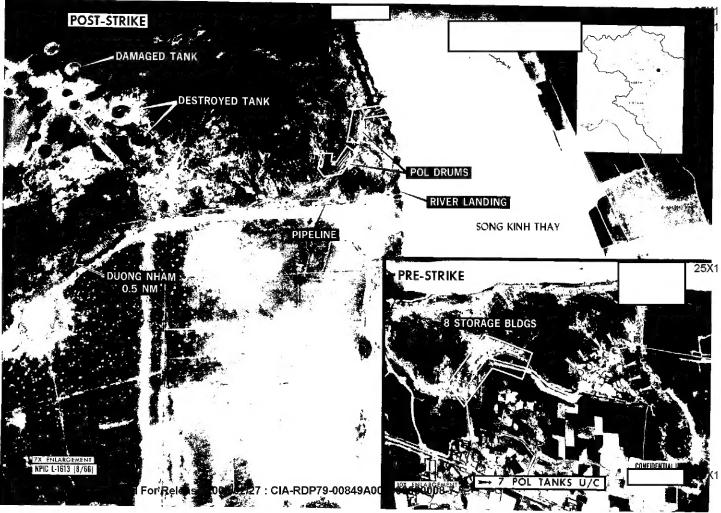
3.	MISSION READOUT:	
	PRE-STRIKE PHOTOGRAPHY REVEALS	2
	A POL STORAGE AREA CONTAINING FOUR POL TANKS UNDER CONSTRUCTION (EACH	
	WITH A U-SHAPED PROTECTION WALL), THREE PROBABLE POL TANK BASES UNDER	
	CONSTRUCTION, AND EIGHT STORAGE/SUPPORT BUILDINGS.	
	(NOT SHOWN ON GRAPHIC) STRIKE PHOTOGRAPHY	2
	REVEALS DENSE BLACK SMOKE RISING FROM THE ENTIRE TARGET,	
	BUT NO DAMAGE IS OBSERVED TO THE NUMEROUS POL DRUMS LOCATED ADJACENT	
	TO THE RIVER LANDING, NOR TO TWO MOTORIZED POL BARGES AT THE LANDING.	
	POST-STRIKE PHOTOGRAPHY OF REVEALS	2
	TWO POL TANKS DESTROYED, ONE TANK DAMAGED, AND ONE TANK INTACT AT THE	
	These notes have been prepared for briefing purposes only and should not be used for detailed analytical work. Their use should be restricted to the particular briefing board(s) they were prepared for and must be considered valid only for the reporting period as indicated by the date of issue. For information concerning these notes contact Chief, Collateral Support

1	REFERENCES: ATTACHMENT TO L-1613 23 AUGUST 1966 PAGE 2
	DUONG NHAM POL STORAGE AREA. THE THREE PROBABLE TANK BASES UNDER
1	CONSTRUCTION HAVE APPARENTLY NEVER BEEN COMPLETED. AT
	LEAST ONE HUNDRED AND THIRTY-SEVEN POL DRUMS IN OPEN STORAGE ARE
	LOCATED ADJACENT TO THE RIVER LANDING AND ALONG THE BASE OF A HILL
	IN A RAVINE. NONE OF THESE DRUMS ARE DAMAGED. A PIPELINE EXTENDING
	FROM THE RIVER TO THE POL TANKS MAY HAVE SUSTAINED DAMAGE.
ſ
